# BUREAU OF SHIPS GROUP TECHNICAL INSPECTION REPORT

OPERATION CROSSROADS.  
U.S.S. FILLMORE (APA83).

TEST ABLE

OPERATION CROSSROADS

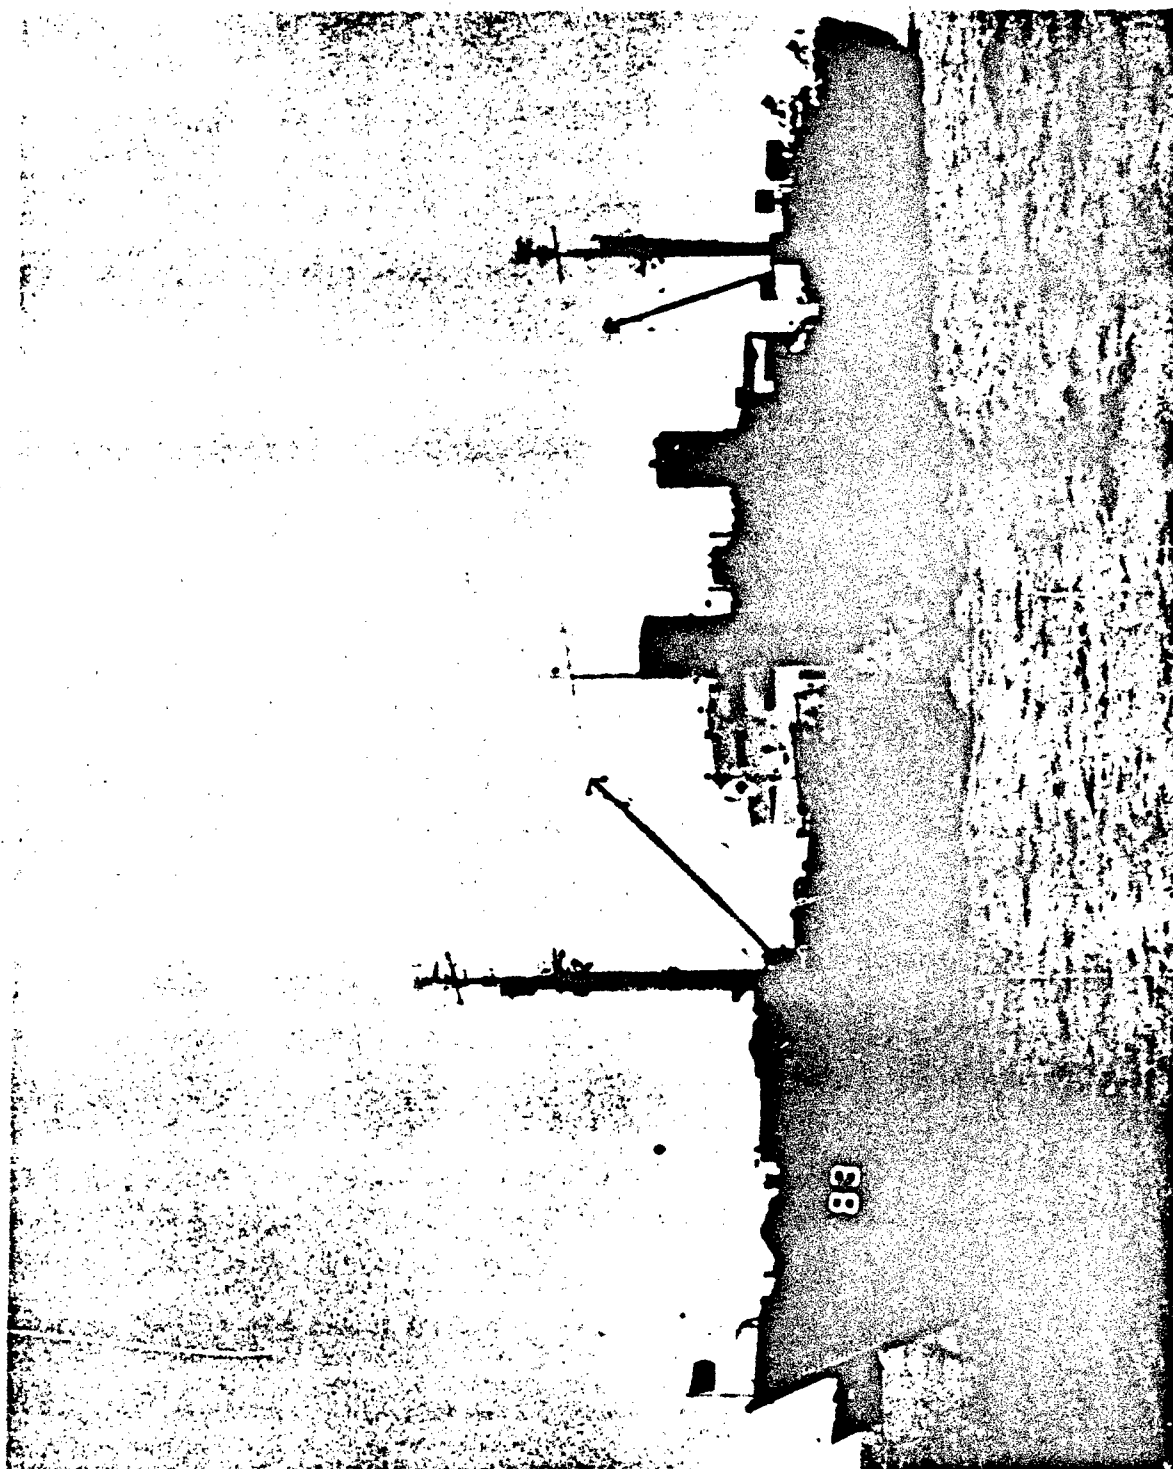
There was no structural damage. The sheet metal port flag bag and signal shack bulkhead are dished. Paint is slightly blistered. Cordage, fire hose, life rafts, and puddings on the port side are slightly charred. Photos 49-21, 25; pages 34, 33, are general views of the ship after test.

AA-CR-227-49-25. Port bow after Test A.

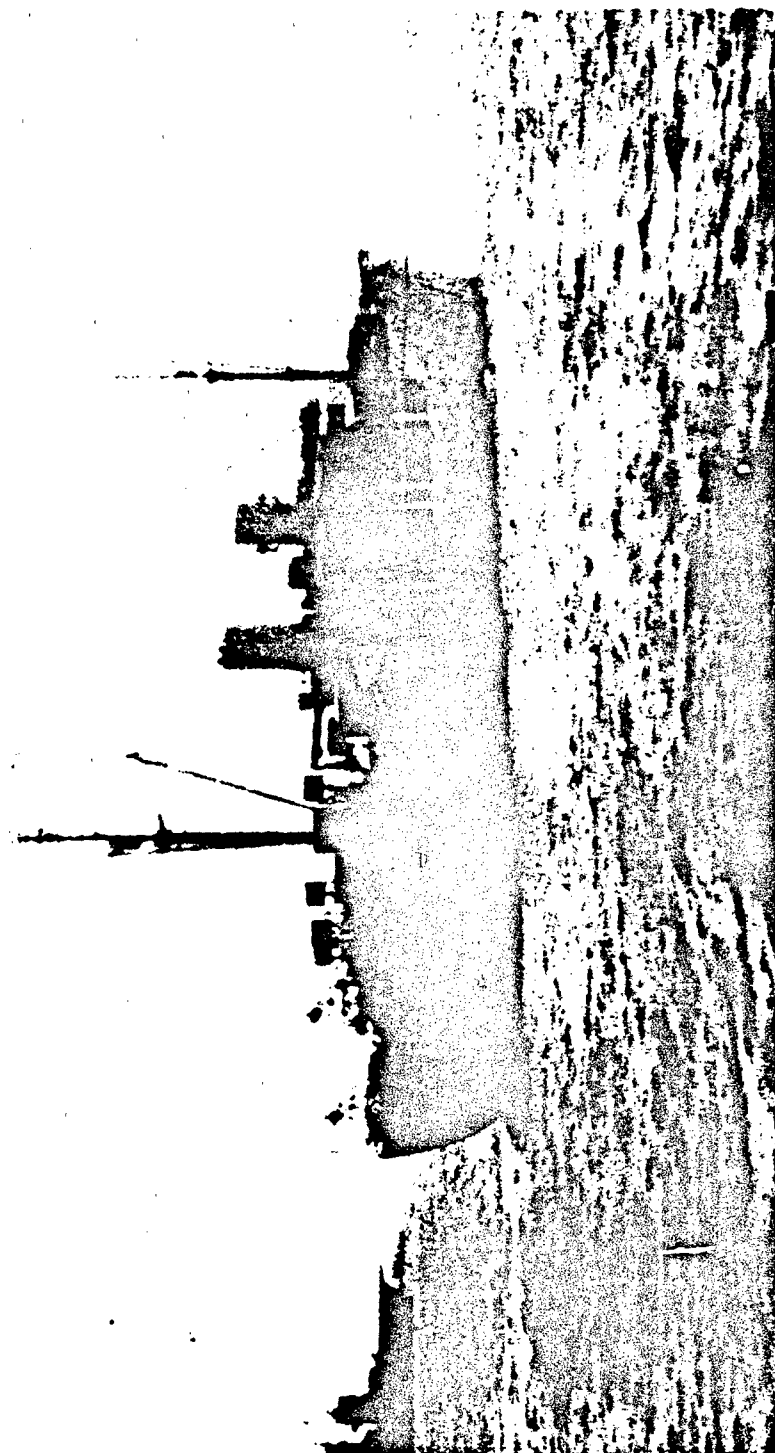
AA-CR-227-49-21. Starboard quarter after Test A.
